Restoration and Refurbishment of St. John's Church, Bangalore

Progress Report

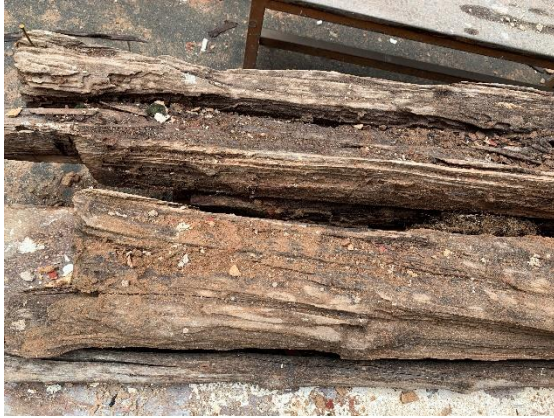
1. Wall plate condition

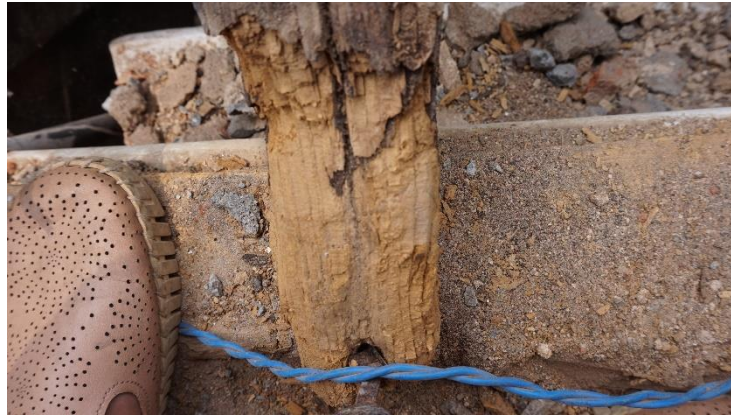
2. Rafter condition

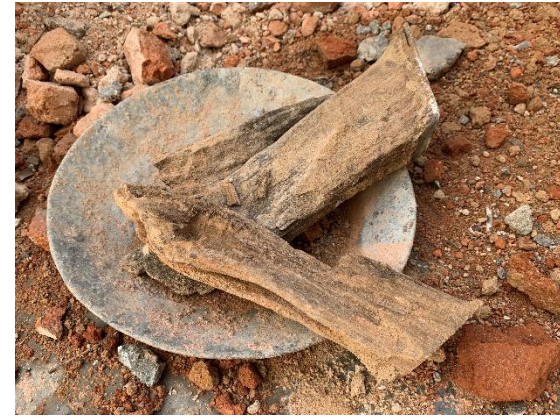
3. Rafter condition

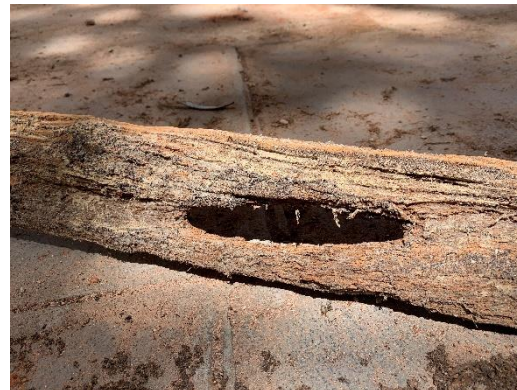
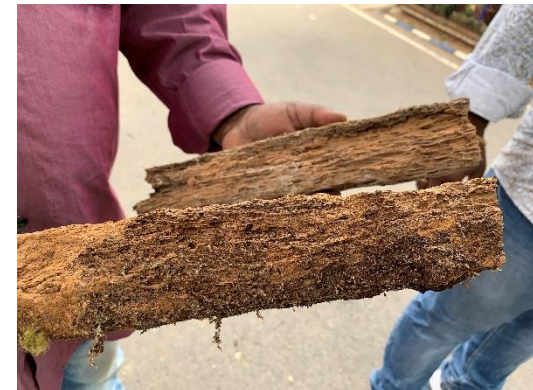
Condition of wall plate

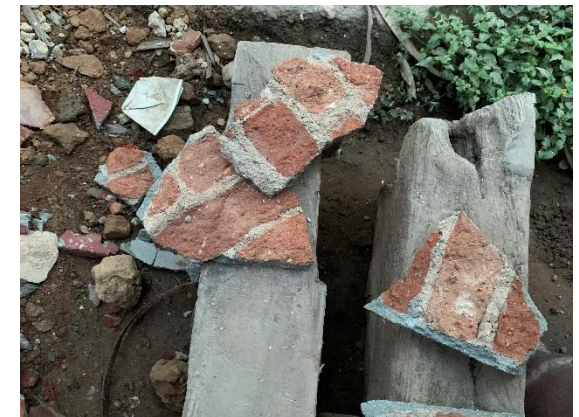
Remains of concrete plaster chipping

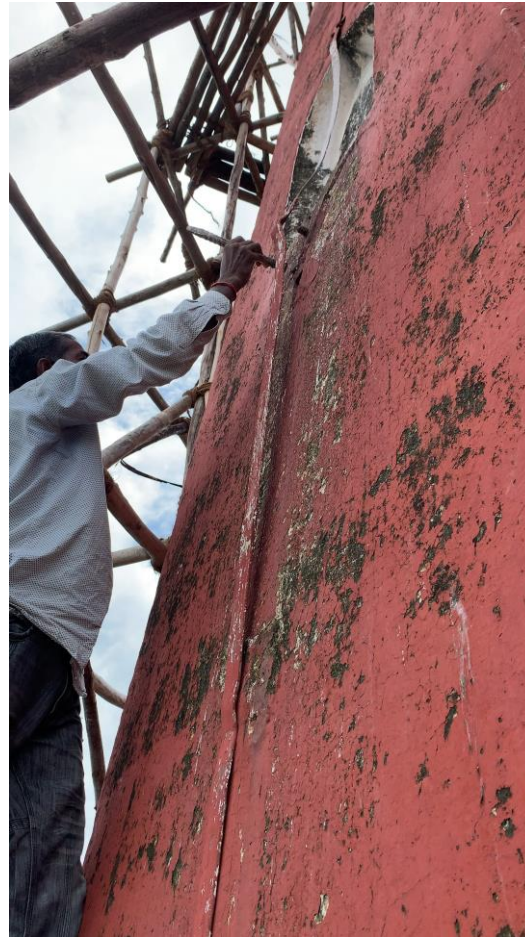
Knock testing of the plaster

1. Erecting scaffolding around the main spire
2. Checking of plaster around the top to estimate the quantity of work. The top tier found to be hollow and patched with cement at certain areas. To be replaced completely.

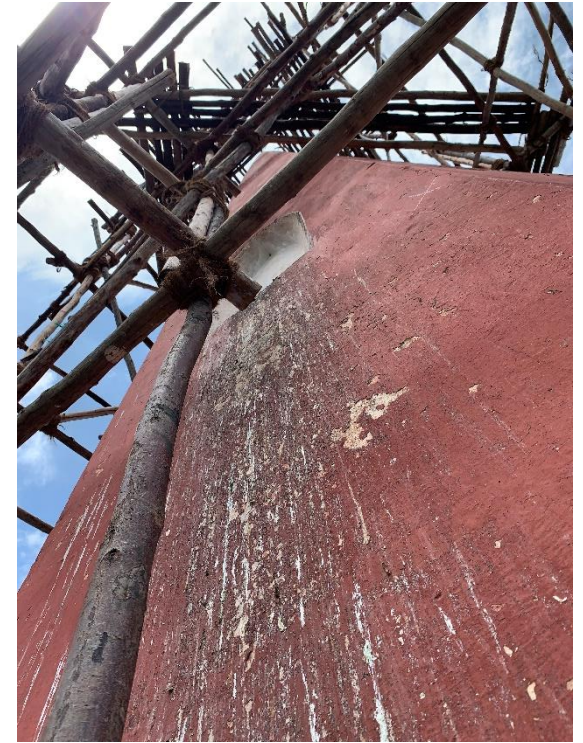
Surface damaged due to bird droppings

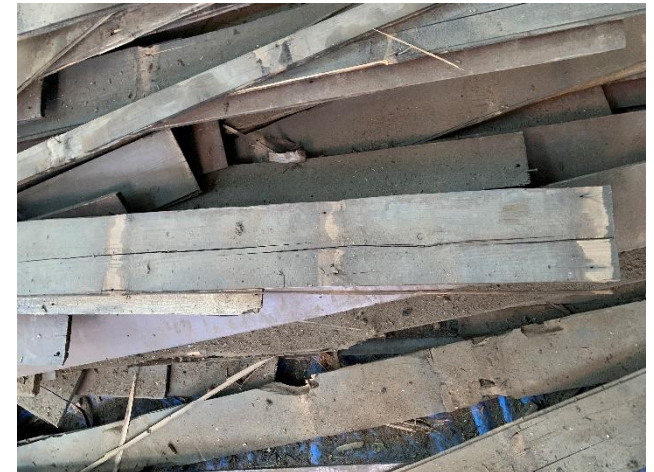
Condition of wood
