Restoration and Refurbishment of St. John's Church, Bangalore

Progress Report

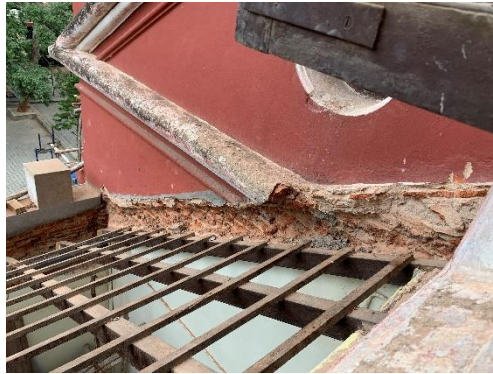
Chipping of wall edge

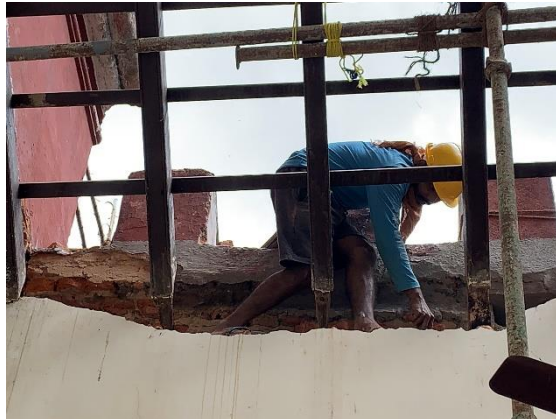
Chipping of wall edge

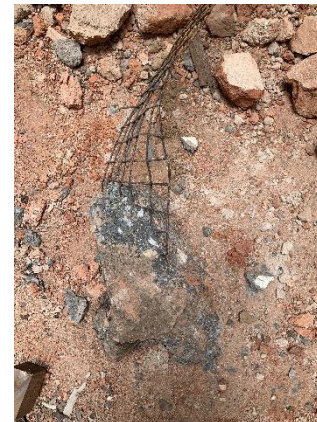
PCC removed from wall edge

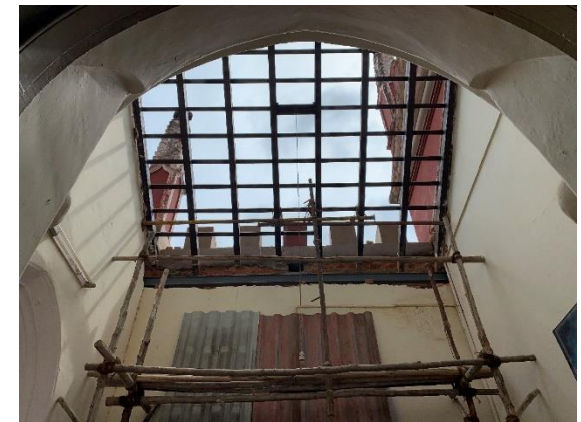
Propping of I section

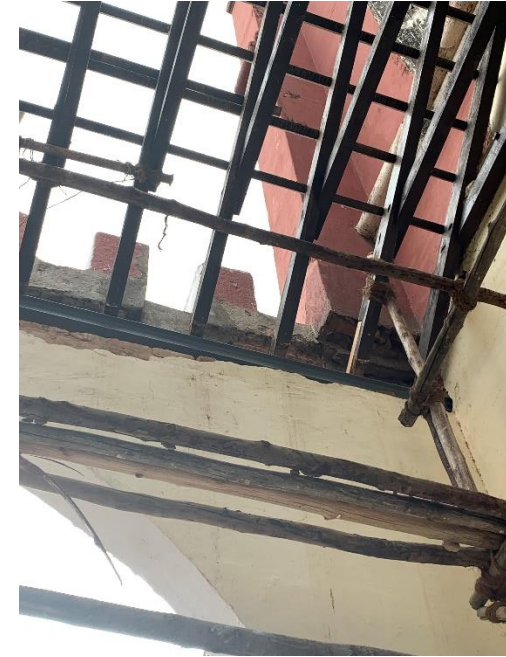
Propping of I section

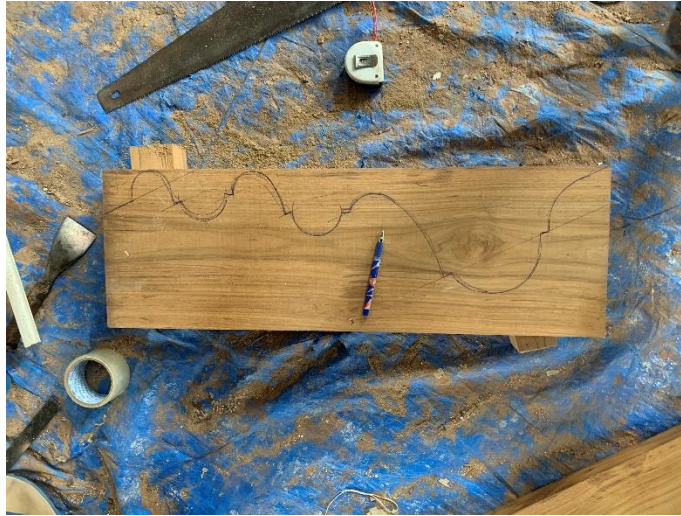
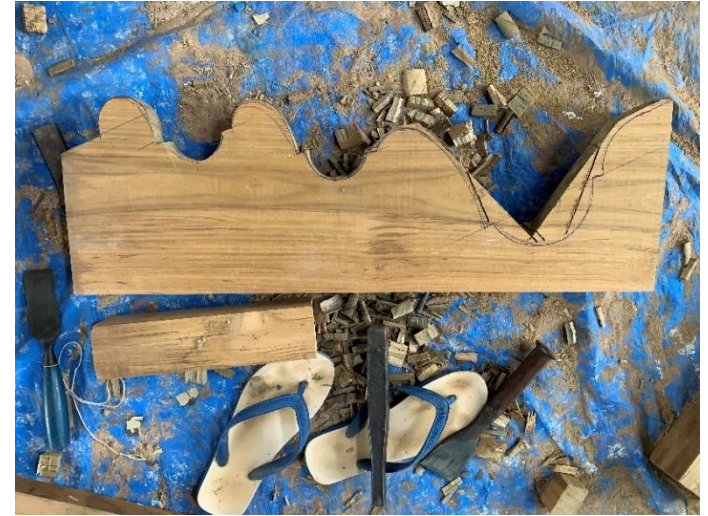
Preparation of wooden template for the arch

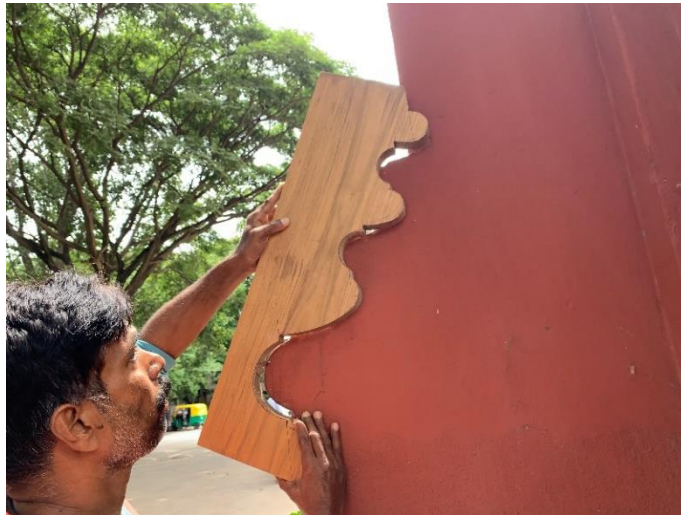
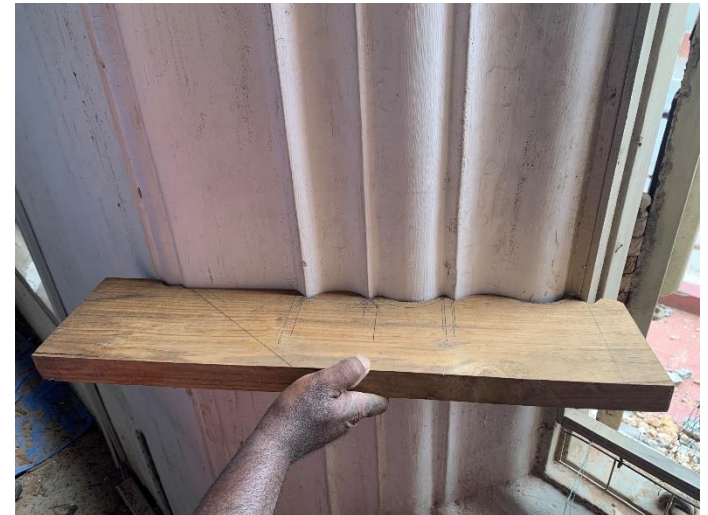
Moulds against the arch

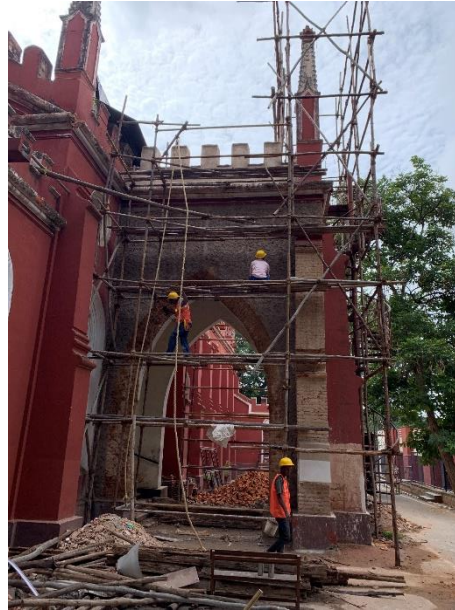
Sample for full plastering

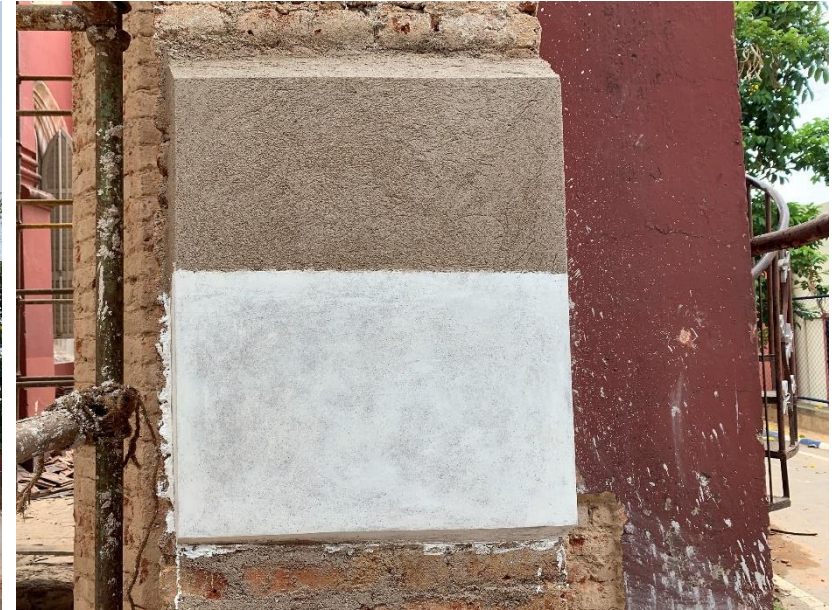
Closeup- sample of the full plaster

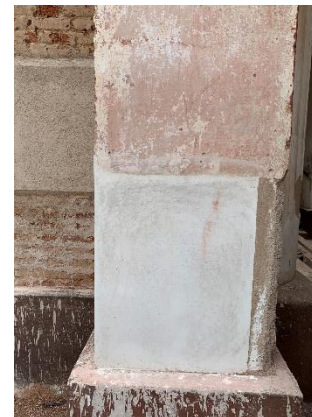
Sample of patch plaster

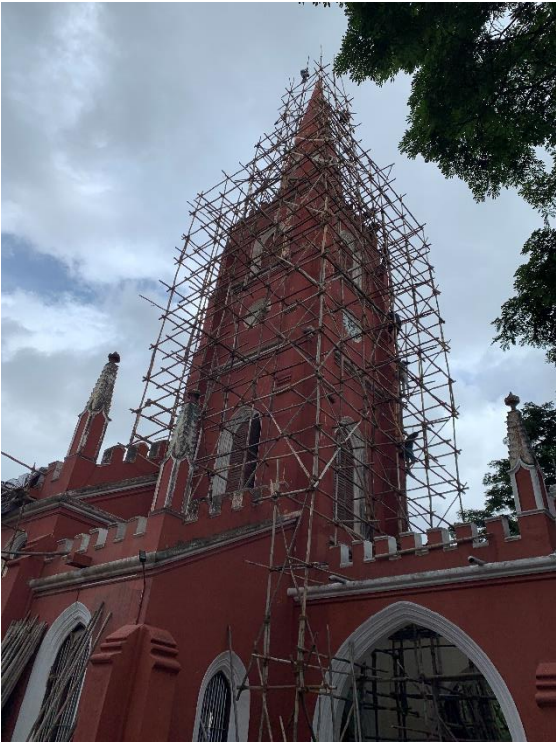
Erection of scaffolding around the spire

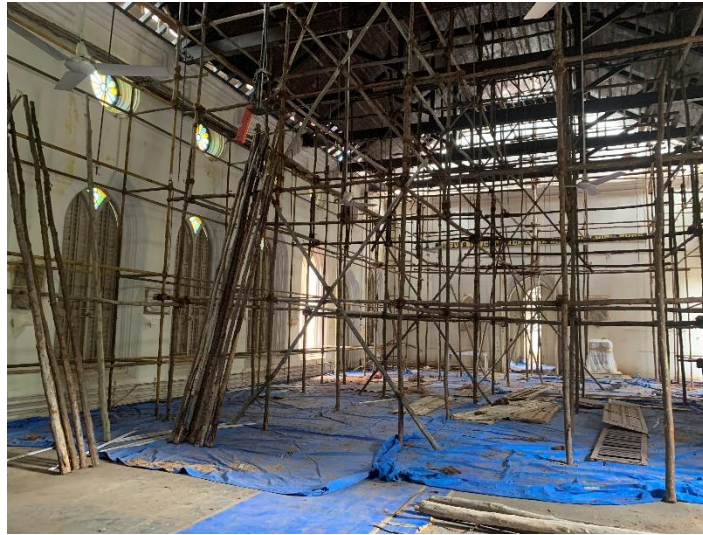
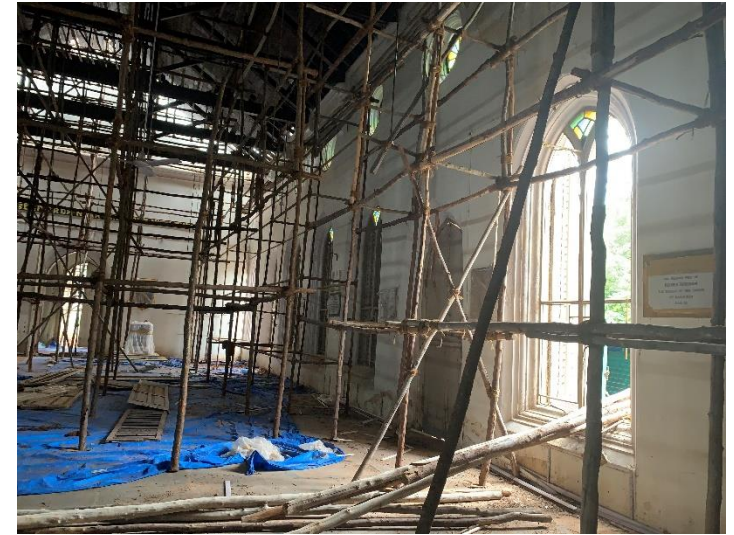
Erection of scaffolding in the Nave

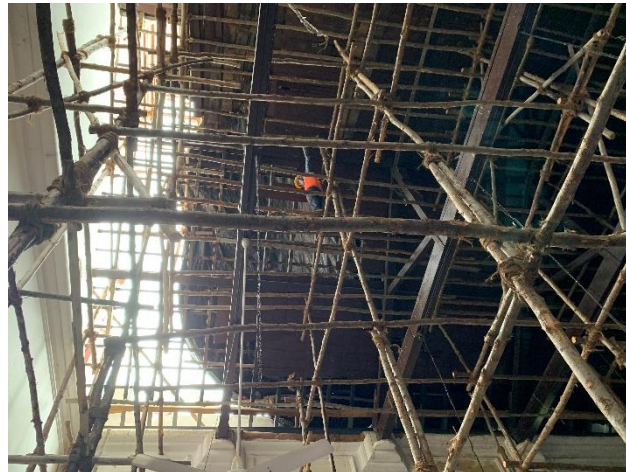
Removal of wooden false ceiling

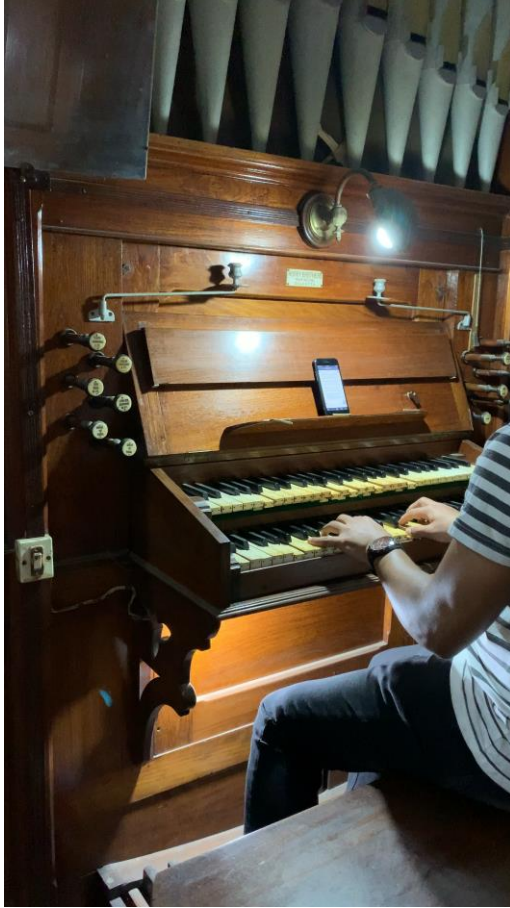
Testing of organ by James

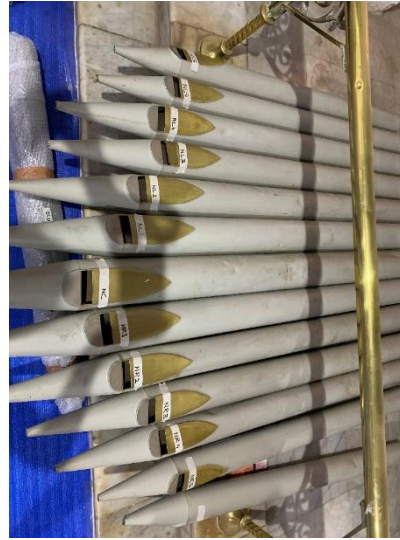
Removal and labelling of external pipes

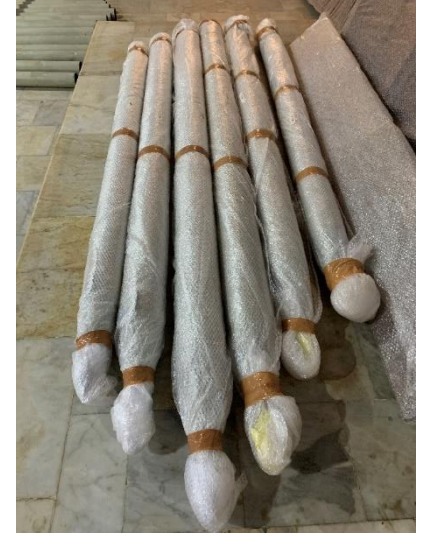
Bubble wrapping external pipes

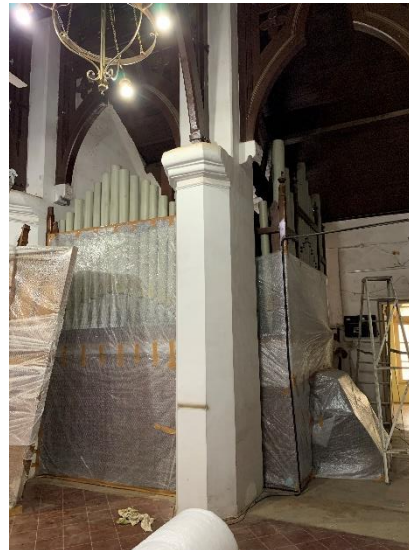
Bubble wrapping of the organ

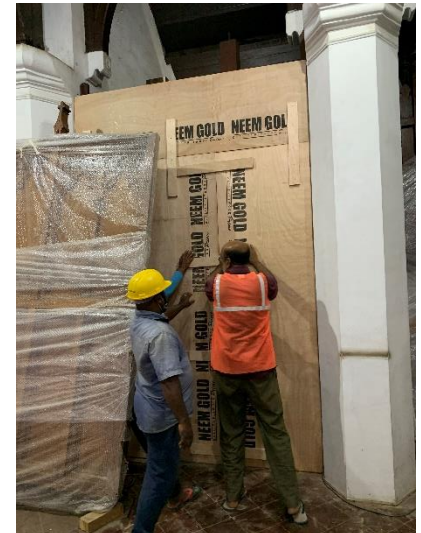
Plywood covering in process

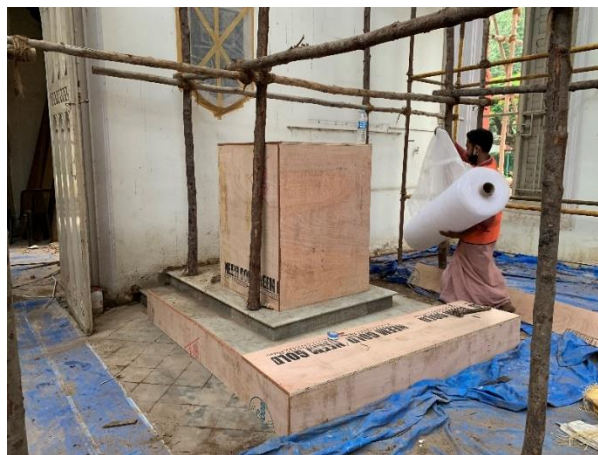
Baptismal Font

1. Covering using bubble wrap and plywood

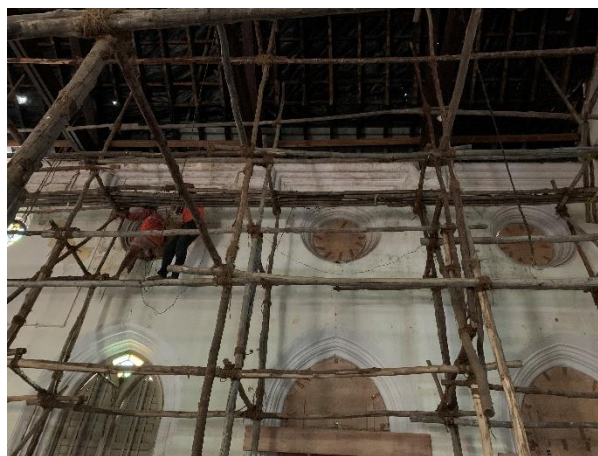
Rose windows

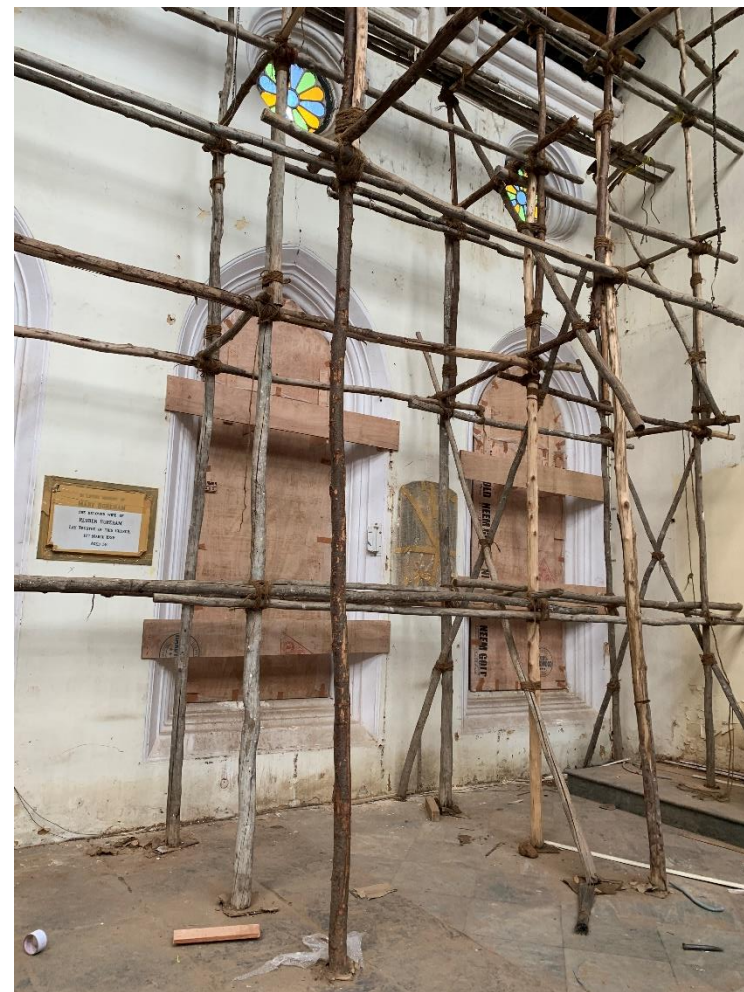
Stained glass windows

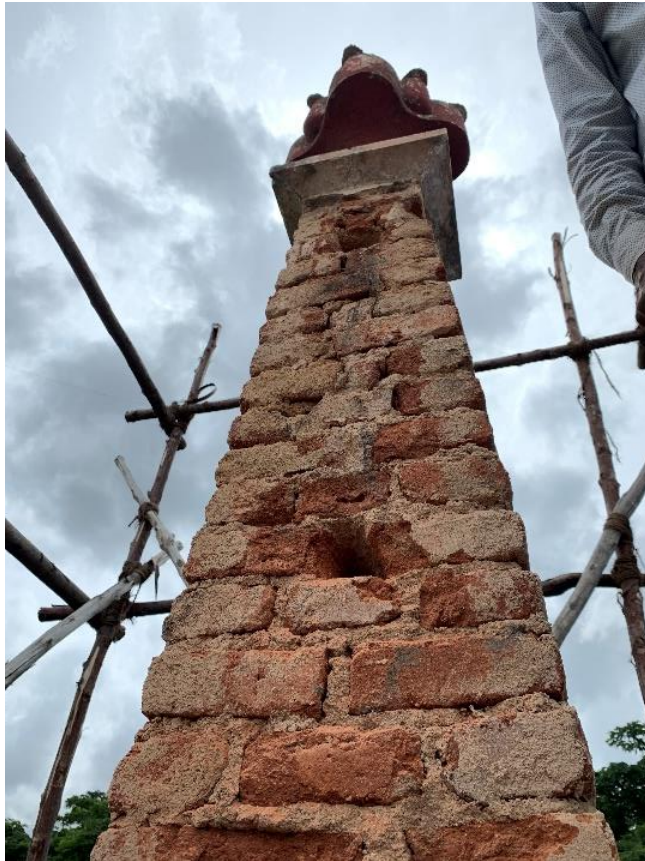
Sample spire at south porch

1. Chipping of old cement plaster and loose lime plaster

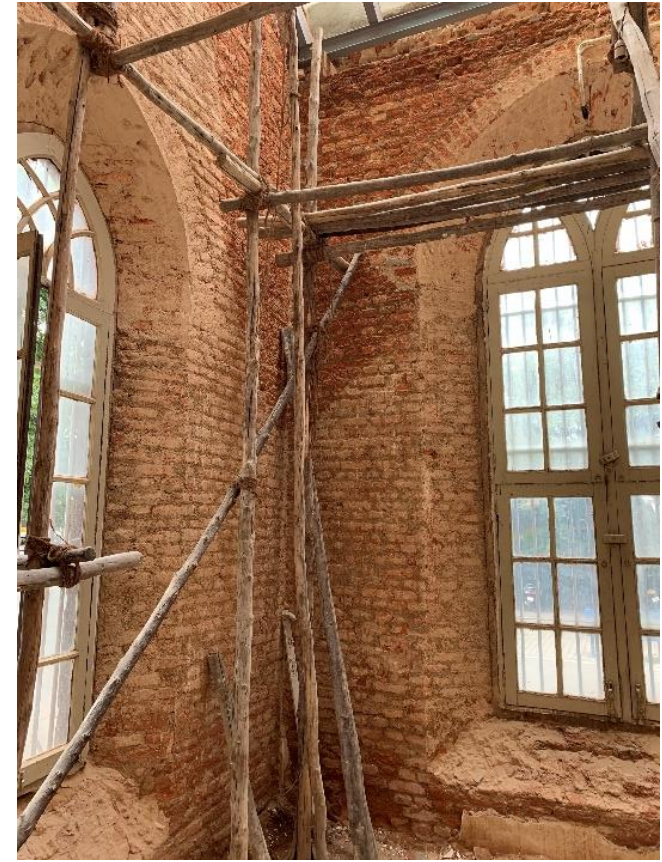
Vestries
